Systems Engineering Investigation of Navy Electrical Bomb Fuzing

Gary A. Evans (Naval Air Warfare Center, Patuxent River, Maryland)

The US Navy, in an effort to identify the root cause of dud electrically fuzed bombs, commissioned an electrical fuzing systems engineering evaluation. The study analyzed the electrical fuzing components, their specifications, operating histories, and interaction into the sub systems that comprise the aircraft/weapon electrical fuzing system. Navy experts for each of the components that make up the electrical fuzing systems focused their efforts into a systems engineering analysis vice a component level analysis.

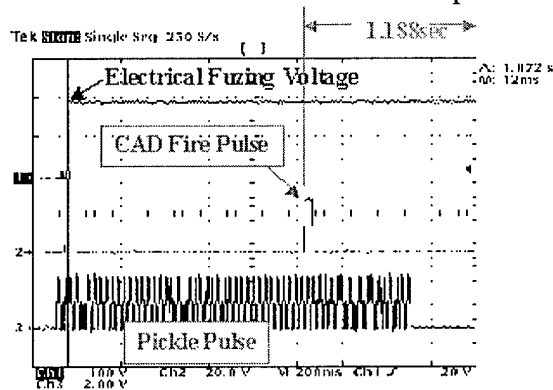
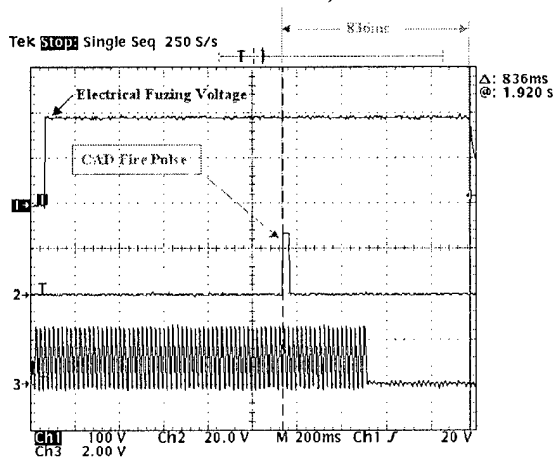
specified limits and of a sufficient duration and magnitude to fully arm the fuze. Figures 3 and 4 show software test data for the JDAM electrical fuzing signal. Both figures 3 and 4 indicate that the proper electrical fuzing signal was present prior to the bomb rack CAD firing. Sufficient signal remained until after the Mk 122 co-axial connector was extracted from the bomb rack connector.

Figure 3
Aircraft Software Data Sample

Figure 4
AYK-22 Electrical Fuze Timing Data
JDAM on BRU-32, TOO release

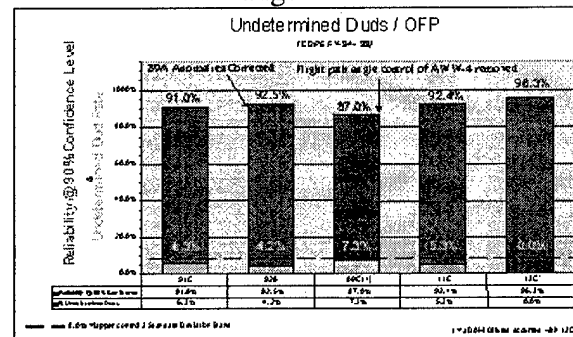
Figure 5

electrically fuzed bomb releases over a period of six years subsequent to the OFF fix. These data shown in figure 5, relate the undetermined dud bomb releases with the aircraft software present in the releasing aircraft. These data were then correlated with the software updates. This analysis identified that no correlation existed between unknown dud bomb rates and aircraft software changes. These operational data agree with the lab test results.

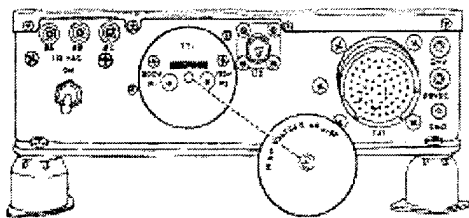
Figure 6
AWW-4

The AWW-4, Figure 6, provides electrical fuzing power to the fuze via several safety interlock devices. It is used in F/A-18 Lot 18 and below aircraft. Its mean time between failure (MTBF) rate was found to far exceed its specification. It has a record in the F/A-18 aircraft of over 2000 flight-hours/maintenance action for a recent 3-year period while only specified for a MTBF of 1000 hours. Its power output is specified at 500ma, which is powerful enough to provide an arming signal to several weapons simultaneously.

AWW-4 and wiring malfunctions were also evaluated. The F/A-18 does not currently perform a built in test (BIT) to verify the AWW-4 is functioning properly. This has the potential to allow an electrically fuzed bomb to be released unarmed if an unknown malfunction is present. Current electrical fuzing checks for available power at the bomb rack are not required unless an

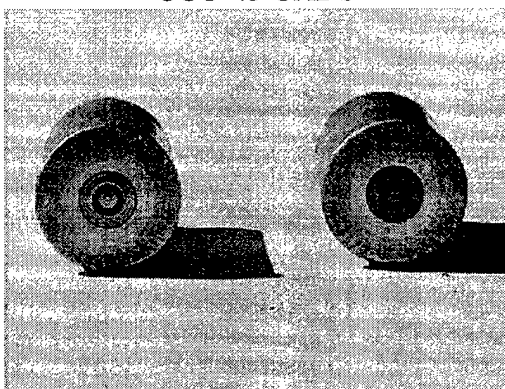
Figure 7
CCU-45 CADS

As part of the systems engineering evaluation, the effect of CCU-45, Figure 7, and delayed ignition was analyzed to determine if it could contribute to electrical fuze duds. Lot and random sampling test data were compared to CAD performance specifications. Lot tests indicated CCU-45s are performing within the specification.

Data analysis from several hundred F/A-18E/F weapon releases using CCU-45s also did not identify any problems. This was verified by subtracting the bomb rack operation time from the CAD spec values shown in Table 1, which contains the CCU-45 specifications. Ignition delay time plus bomb rack ejector piston end of stroke was less than 110ms in all cases for Mk 82, 83, and 84 bombs.

Therefore, lot and random sampling tests of CCU-45s have not identified any CCU-45 reliability issues related to electrically fuzed bomb dud rate. Ignition delay time alone would need to be in excess of 100 ms to have an impact on older OFPs (87D, 10A, 89A). Newer OFPs (13C and 15C) would require an ignition delay in excess of 700ms

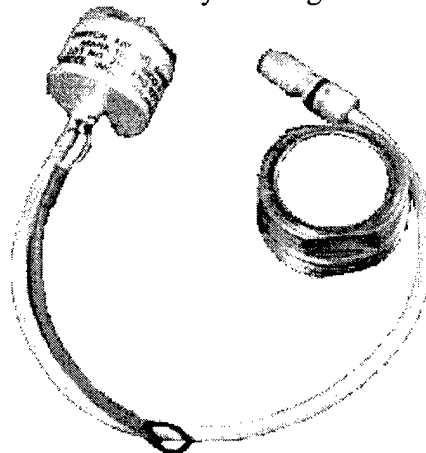
Figure 8
Mk 122 Safety Arming Switch

The Mk 122 Safety Arming switch, Figure 8, was developed in the early 1960's. It transfers aircraft fuze power to GP bombs. It was developed when bombs were ejected with relatively low ejection velocities compared with modern bomb rack units (BRU) such as the BRU-32 on the F/A-18 and F-14. The Mk 122s were first produced in March of 1963 and the last lot was produced in 1975. The majority of the remaining inventory of switches was manufactured between fiscal years 1970 and 1973.

low resistance paths to ground (or short circuits) are allowed. The lanyard length is 5.875" +0.250/-0.188 and the Co-axial cable length is 13.050" +.000/-0.375. Several Aircraft/ Mk 122 interface factors were identified during this analysis that can reduce fuze capacitor charge time and contribute to or directly cause a bomb to dud.

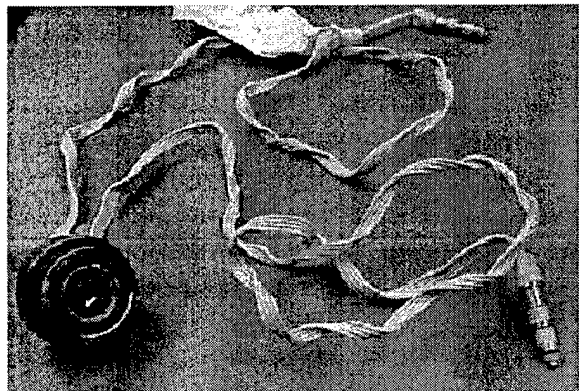
Figure 17
M70 Bomb
Cable

The M70 cable, figure 17, is routed inside Mk 80 series GP bomb body conduits. The cables are installed when the bombs are manufactured. Its purpose is to pass FFCS power from Mk 122 switch to the fuze. Testing of the cable prior to bomb assembly was discontinued due to high reliability. The only identified weak link was the cable spring clip / fuze interface, but no data exists to determine if this connector is presently contributing to the undetermined dud rates. As the inventory of bombs age, the potential for corrosion on connectors increases. Limited random sampling of test assets did not identify any problems. Therefore, the M70 cables at this time are not thought to be a significant contributor to electrically fuzed bomb duds.

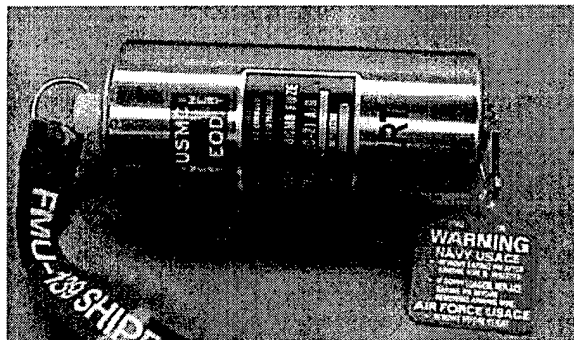
Figure 18
FMU-139 Electrical Bomb Fuze

The FMU-139 Electrical Bomb Fuze, figure 18 requires 15 ms of fuze function control set (FFCS) power to arm. It has been verified to function with less than the specification charge time, but its reliability is based on a full charge of 15 ms and without this it may not meet the specification operating life of 60 seconds. Most of the fuze power is used to reach arm time. Some

power is used after Arm Time is reached. The fuze capacitor is specified to have a 95mA max current draw. Tests have identified 80mA are typical. The fuze reliability specification is 95% reliability at a 90% confidence level. Based on Navy bench tests the fuze has demonstrated a 98.3% reliability at a 90% confidence level well above the specified value. These tests however were performed without the booster installed. Controlled aircraft flight tests performed by the U.S. Air Force also show the FMU-139 to exceed the specification at 97% reliability at a 90% confidence level. Therefore, when the fuze is given the proper minimum required charge profile and duration of 15 ms both the Navy and Air Force experienced similar reliability at a 90% confidence level using different test methods.

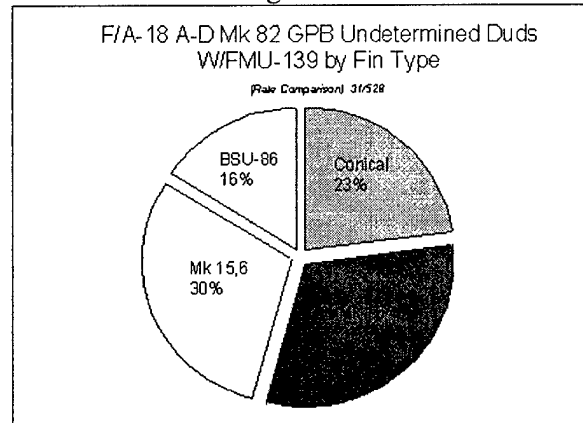
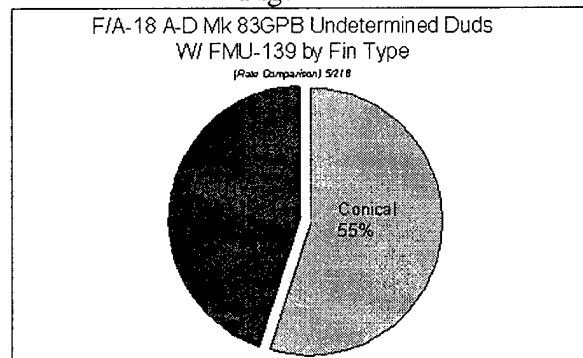
The effect of different bomb tail sections was also analyzed as part of the investigation. Undetermined dud rate data was correlated by bomb tail section for Mk 82 bombs figure 21 and Mk 83 bombs figure 22. From this undetermined dud rate data it was determined that any major source of unknown duds seem to be independent of fin type. BSU-86 and Mk 15 fin wire failures caused by fin blade movement do not appear to be excessive from training flight profiles that this data is taken from.

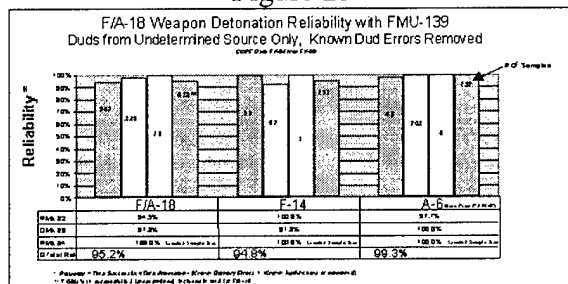
Weapon reliability data from the Conventional Ordnance Performance Evaluation (COPE) program and Conventional Ordnance Deficiency Report (CODR) were used in this analysis. Six years of data FY94-FY99 were compiled and correlated to determine weapon system reliability, which includes both the aircraft and the weapon. This analysis includes data for FMU-139 fuzed weapons only. Figure 23 shows COPE dud rates from undetermined sources only. The data shows that the F/A-18 and F-14 have a similar reliability, during this period in training, of approximately 95% (same as the fuze specification). The A-6 had a significantly higher reliability during this period. Several factors may contribute to this perceived

higher reliability rate for the A-6. First, the sample size for the A-6 was limited. Second, the data were older encompassing only two years (FY94 and 95) and the A-6 was a two-aircrew platform. Finally, delivery airspeeds were lower and the ejection velocities were lower. From the COPE data only the F/A-18 sample size for Mk 82 and Mk 83 single E-fuzed bombs which was greater than 800 was sufficient for additional analysis.

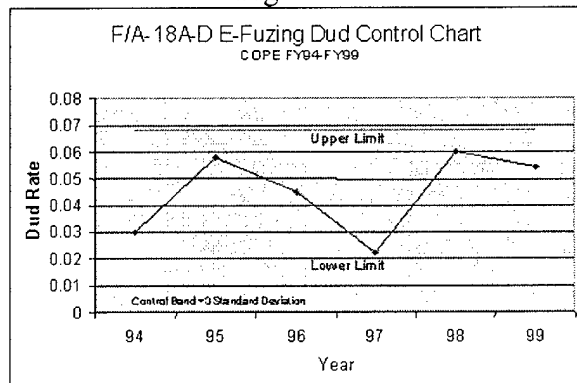
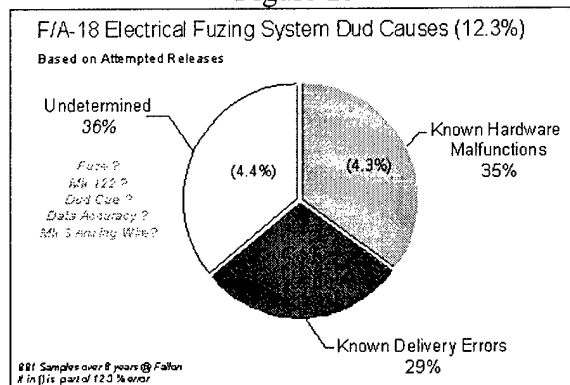
The F/A-18 COPE data set were first verified to ensure they fit within the 3-sigma control limit constraints, figure 24. From analysis of the F/A-18 COPE data, the duds were split into three categories as depicted in figure 25. The first of the categories, known delivery errors, had a 3.5% delivery error rate. The second category, known hardware malfunctions, had a 4.3% hardware failure rate. The third category, undetermined dud sources, had a 4.4% undetermined dud rate.

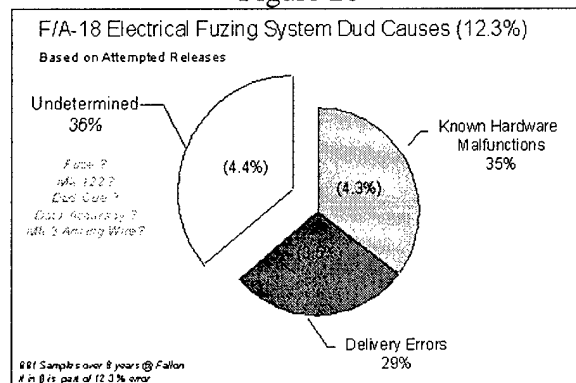
Figure 28

The F/A-18A thru D aircraft electrical fuzing system is at least 95% free of unknown failures. Zero to 4.4% of F/A-18 duds could be attributed to an unknown failure mechanism; however, it is highly unlikely. There is a high probability that the majority of the 4.4% of unknown failures depicted in figure 28 fit known hardware or delivery failure modes. Hardware issues such as fuze failures, Mk 122 cable routing, rack dynamics, tolerances, aging, and Mk 3 arming wire breakage combined with known delivery errors - too slow, time of fall, and dud cue tolerances leave little room left for any serious unknown root cause failure mechanisms to exist.

Full systems tests to characterize in flight electrical fuzing performance have never been conducted on the F/A-18 due to the perceived high cost. Testing of weapons in the operational configuration with functional hardware can identify problems early. This is not often done due to the cost during developmental testing. Most of the causes of electrically fused dud bombs found in this study could be identified by a full systems evaluation prior to operational deployment. Operational data gathered from programs such as the COPE program is indispensable when completing a systems engineering evaluation.
